Final Report

A STUDY OF THE STRESS CORROSION SUSCEPTIBILITY OF CUPRO-NICKEL AND TITANIUM UNDER DESALINATION CONDITIONS

UNIVERSITY OF DENVER
DENVER RESEARCH INSTITUTE

Office of Saline Water
U. S. Department of the Interior
Washington, D. C.

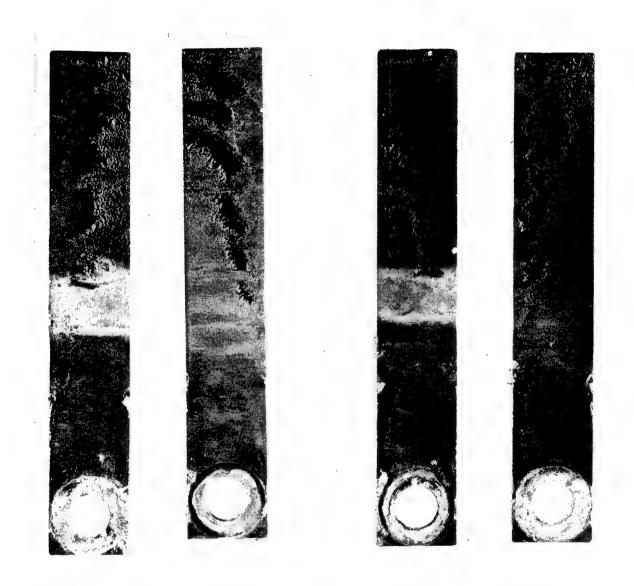
In order to confirm that the corrosion rates evaluated from the stress corrosion specimens were reasonably valid, some corrosion coupons (3 in. × 0.5 in. × 0.05 in.) of 90Cu-10Ni were run at 8 to 10 fps in 11% brine at room temperature. This test was performed with the cooperation of Dr. D. T. Klodt of this laboratory who was responsible for an investigation of the effects of velocity on the passivation of alloys in brackish water for the Office of Saline Water (Contract No. 14-01-0001-1335). After exposure for the same period (49 days) as the stress corrosion samples, an average corrosion rate of 19.2 mpy was obtained from weight-loss measurements. This is about two-thirds of that (27.1 mpy) obtained by the other method. This difference in the average rate is attributable to the less uniform attack of the corrosion coupons, as manifested in Figure 11. The surface appearance of 90Cu-10Ni stress corrosion specimens tested at 8.5 fps in 11% brine at room temperature is shown in Figure 12 for comparison. In turn, the uniformity of attack could be due to the specimen size difference, and also to its position relative to the Teflon impeller and flow direction.

Figure 11. Surface Appearance of Typical 90Cu-10Ni Corrosion Coupons Exposed for 49 Days at 8 to 10 fps in 11% Sea-Salt Brine at Room Temperature

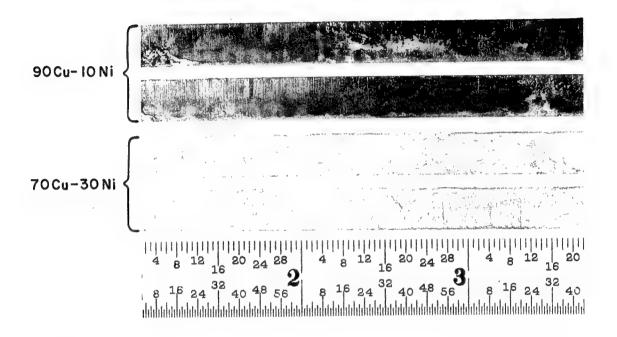
Figure 12. Surface Appearance of 90Cu-10Ni and 70Cu-30Ni Stress Corrosion Specimens Exposed for 49 and 47 Days, Respectively, at 8.5 fps in 11% Sea-Salt Brine at Room Temperature

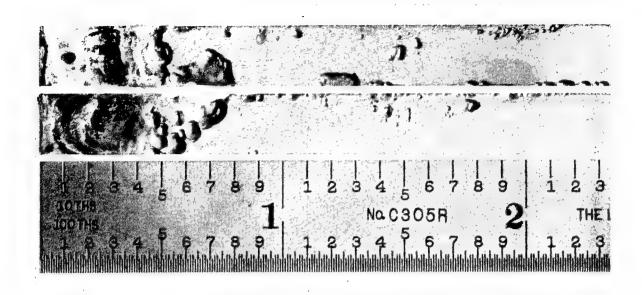
Other examples of the result of dynamic exposure to the brine solutions are given in Figures 13 to 18. In general, corrosion pits were somewhat more numerous in that region of the surface near the leading edge of the specimens, and near the ends of the specimens where the RTV coating terminates. Rather than a crevice effect, the latter is thought to be the result of excessive turbulence at the specimen-fixture junctions since the C-rings did not experience similar effects (Figure 15).

Figure 13. Surface Appearance of 90Cu-10Ni Stress Corrosion Specimens Exposed for 49 Days at 8.5 fps in 11% Sea-Salt Brine at 204°F

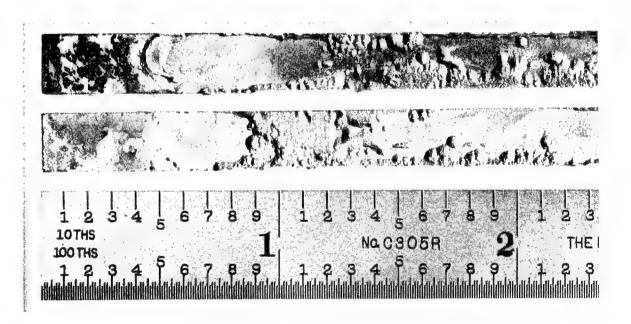
Figure 14. Surface Appearance of 70Cu-30Ni Stress Corrosion Specimens Exposed for 47 Days at 8.5 fps in 11% Sea-Salt Brine at 204°F

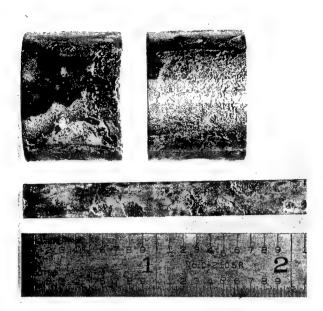
Figure 15. Surface Appearance of 90Cu-10Ni Tube Specimens Exposed for 42 Days at 8.5 fps in 11% Sea-Salt Brine at 204°F. Top Left: Seamless C-Ring; Top Right: C-Ring with Weld Seam; Bottom: Longitudinal Bent-Beam

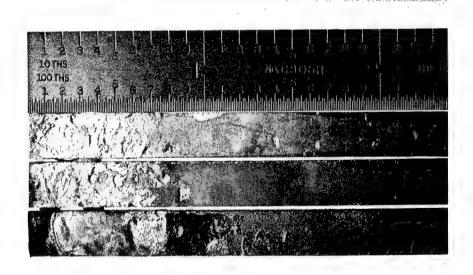
Figure 16. Surface Appearance of 90Cu-10Ni Exposed for 43 Days in 11% Sea-Salt Brine at 250°F. Top: Sheet Cold-Rolled 50%; Center: Annealed Sheet; Bottom: Longitudinal Tube
